## **SURFACE QUALITY OF STEEL TUBES AND THEIR BEHAVIOR DURING SERVICING IN BOILERS**

**Abstract:** *The quality of seamless steel tubes usually is concerned on geometrical measurements, mechanical testing and rarely on checking the chemical composition. After a years in service, many kinds of damages on steel boiler tubes are available. The servicing conditions at a boiler plant (temperature, pressure, water quality, etc.) certainly have an important influence on the behavior of seamless tubes, so many parameters have to be controled, but the surface state of used tubes does not is concerned on an adequate manner. It is registered that frequently the surface of boiler tubes are responsible for metal degradation, it means that boiler is failed, and production process is stopped.*

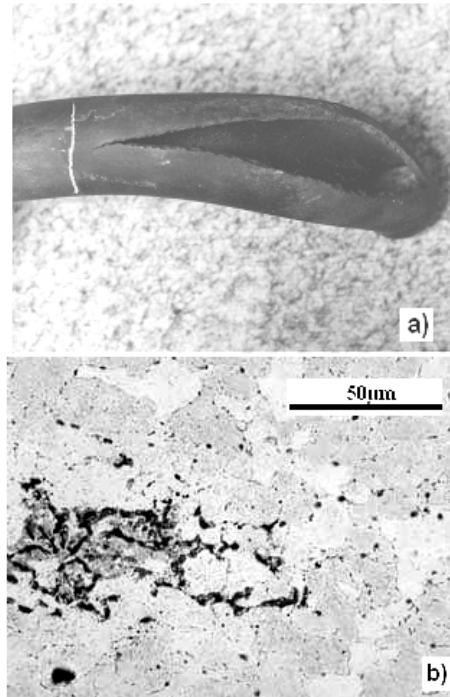
Metallographic view shows that the initial structure is composed from ferrite and pearlite, and finely dispersed carbides, and it is commonly and expected structure in this kind of steel grade, 15 Mo 3 (Č 7100). All around on the outer diameter of tube were visible a lot of smaller striations, but just one has lead to the cracking. The crack is started from the surface, and propagate through the tube wall. The reasons for such crack should be search in: a) tube manufacturing process and b) servicing conditions [3,6].

It's really impossible to explain the nature of longitudinal crack from. Fig. 2, only by servicing conditions or chemical inhomogeneous of steel.

*Figure 2 – Longitudinal crack at 15 Mo 3 boiler tube a) and microstructure in cross section b)*

So, the nature and origin of longitudinal crack should be search in a manufacturing process.

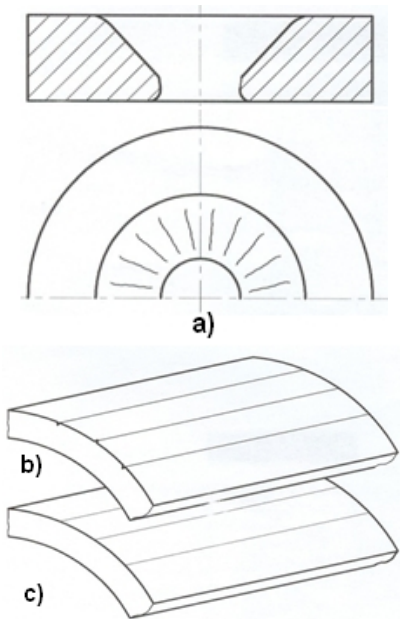
**Figure 5 – Striations at die surface a), striations at tube surface b) and squeezed irregularities into surface c)**

The corrosion products were present in those boiler tubes, but the main reason for tube failure could not be notified only as a consequence of a corrosion process: if the corrosion failure is happened than the straight longitudinal crack simply could not be appeared. The straight lines at outer surface of a tube became visible usually after a long period, but here they were

registered after shorter time, about 15000 h. For such surface irregularities the response lies in drawing die, Figure 5a). The drawing die during working cycles is undergoing to wear. Sometimes the wear at the die diameter is not uniform distributed, rather is localized making striations. Striations from the drawing die will be copied on the outer diameter of tube, Figure 5b). After final, calibrating, drawing the smooth surface will be obtained but the striations were squeezed onto the surface. After a while, during working of such produced tube in boiler (hot) conditions, such irregularity will be open and this will be a real place for crack appearance, as registered in Figure 2.

The failure is oriented in longitudinal direction. Such crack could not be explained by regular working conditions in boiler plant, but the quality of tube surface. For obtaining of squeezed surface is responsible the drawing die with partially damaged working surface, it means that frequently re-grindings are missed.
